Hebron Pool Study

STUDY & REPORT

JEO CONSULTING GROUP, INC.

**STUDY AND REPORT
FOR
HEBRON POOL**

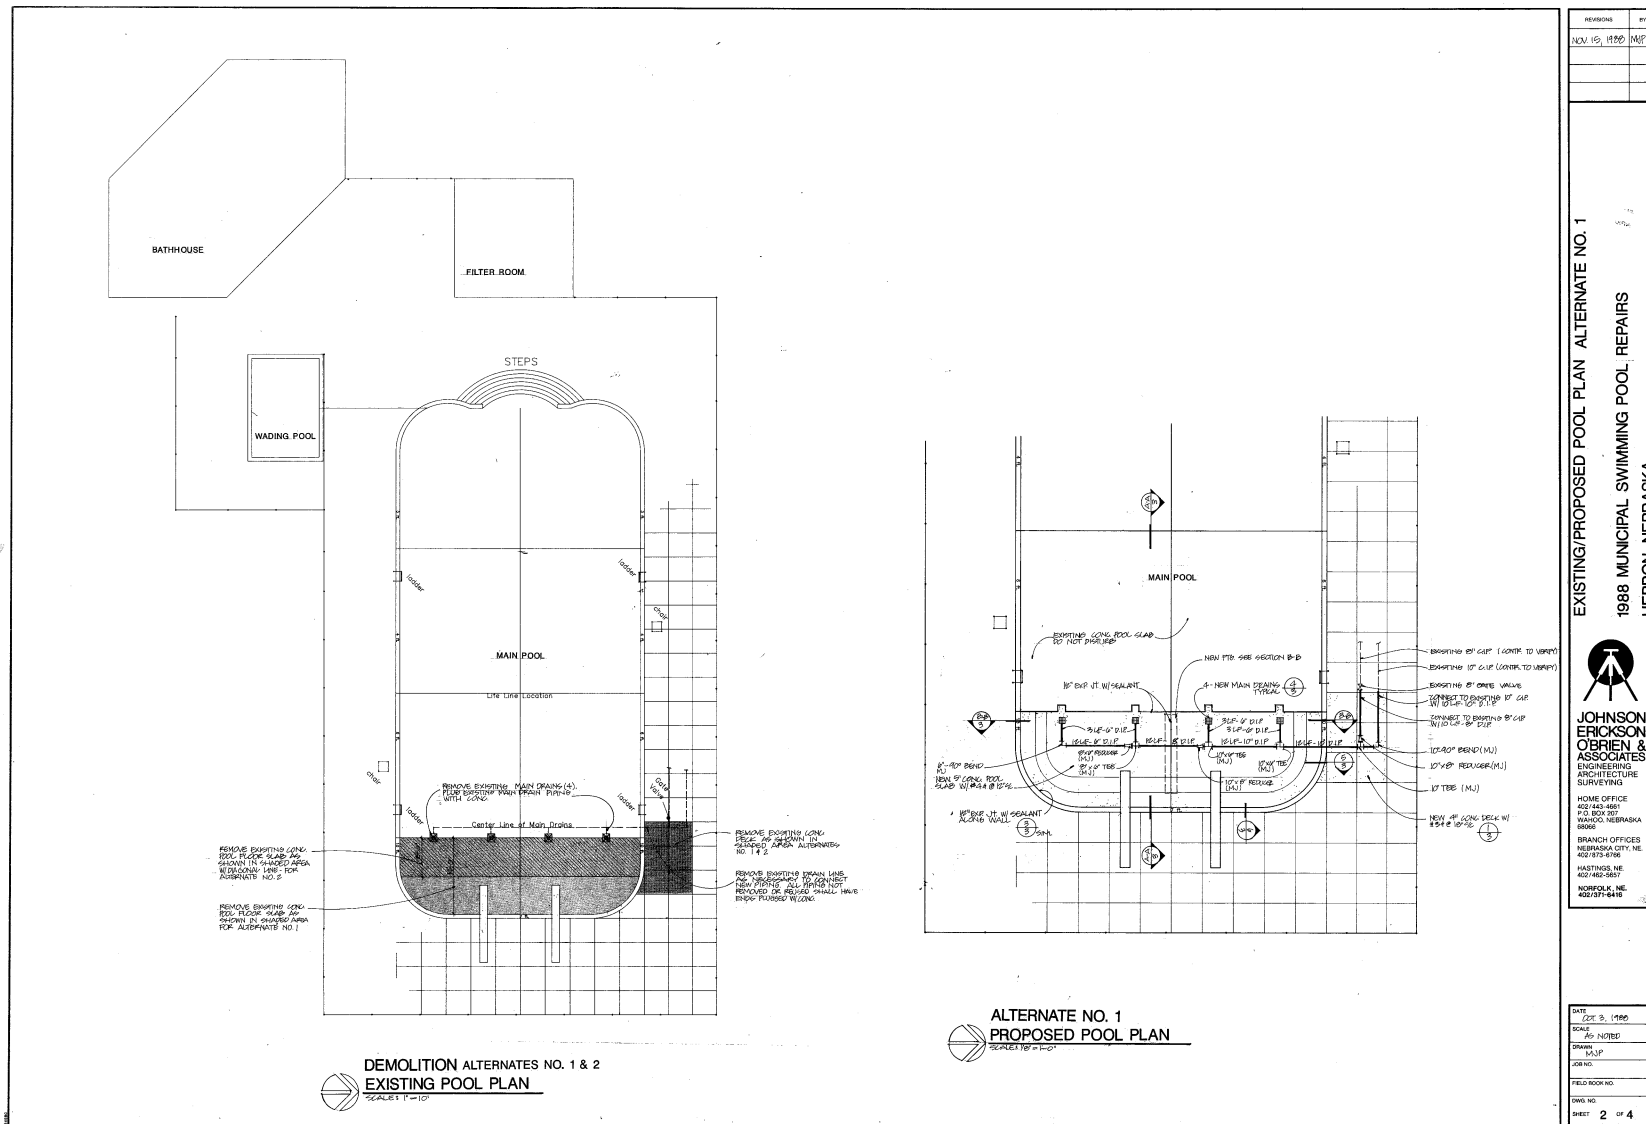
Figure 2-1: Pool Renovation Plan

- Pool was built in 1930s
- The wading pool was added in the 1960s
- Bathhouse was added in the 1976. Pool piping and concrete deck was also replaced in 1976.
- Pool was renovated in 1988. The deep end of the pool basin was renovated. New drains and piping were installed and a new floor slab.
- Slide was installed in 1990s.

The Renovation in 1988 can be seen in **Figure 2-1: Pool Renovation Plan** and **Figure 2-2: Pool Renovation Profile**.

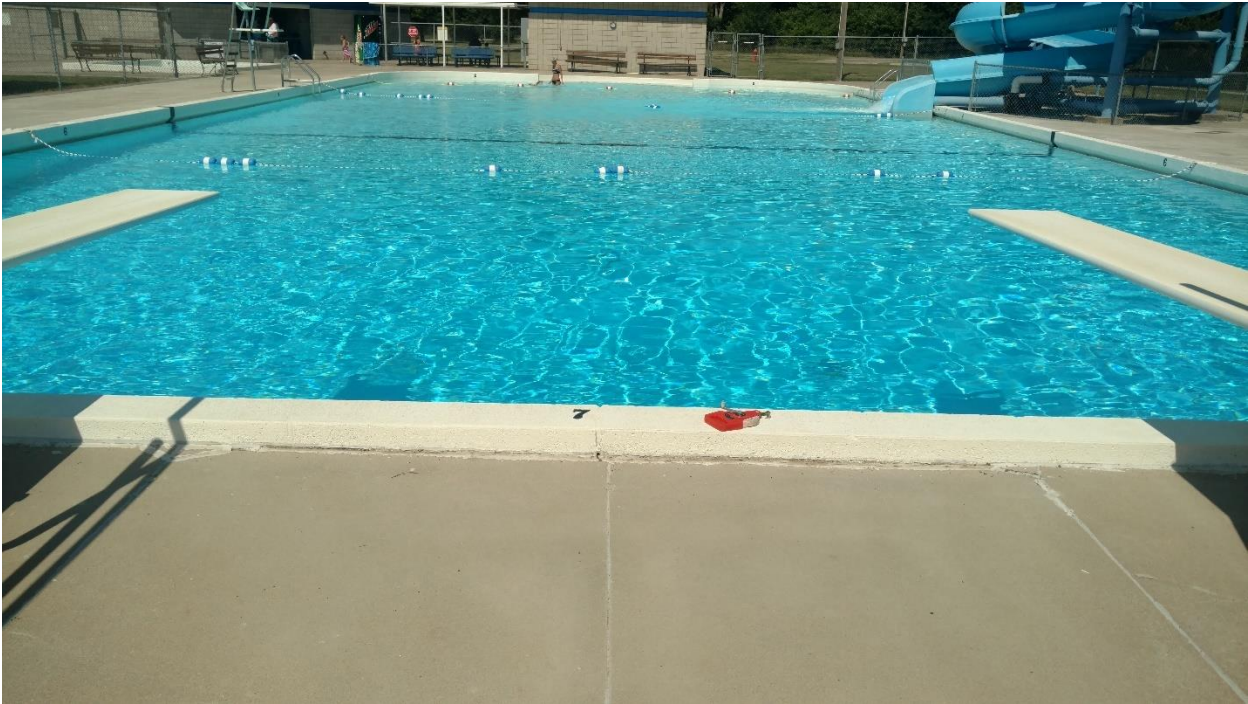
Figure 2-3: Hebron Pool

The Hebron pool is a concrete swimming pool built in the 1930s. It is approximately 50' wide and approximately 110' long, and it holds approximately 250,000 gallons of water. The pool has 2 single pedestal diving boards, a 15' tall slide, 4 pool ladders, 2 stationary 2-meter lifeguard towers, and 1 staircase into the pool. The posted depth of the pool ranges from 2' to 10'.

The 5' depth line for the pool is currently at 4'4" and the pool rope is at 7'. Both the rope and the 5' depth line do not meet standards, as they should be at 5'. Some of the depth markers for the pool are placed too far apart and do not meet design standards. There is no heating system for the main or wading pool and patrons complain of the cold water. One pool wall is bowing slightly, and this can be seen in **Figure 2-4: Bowing Wall**. The facility has some exterior lighting, but they do not use them because the lights are too close to the deck and draw too many insects. The facility is surrounded by a 6' chain link fence which is in fairly good condition. However, the fence does not provide any gate for egress in the event of an emergency. Lastly, the concrete pool deck appears to be in good shape.

The pool leaks enough that the city runs a garden hose continuously during the pool season to maintain water level. City staff indicated that if water was not added to the pool, the water level in the pool would drop approximately 3" per day. The pool has been leaking like this for the last 10 years or more.

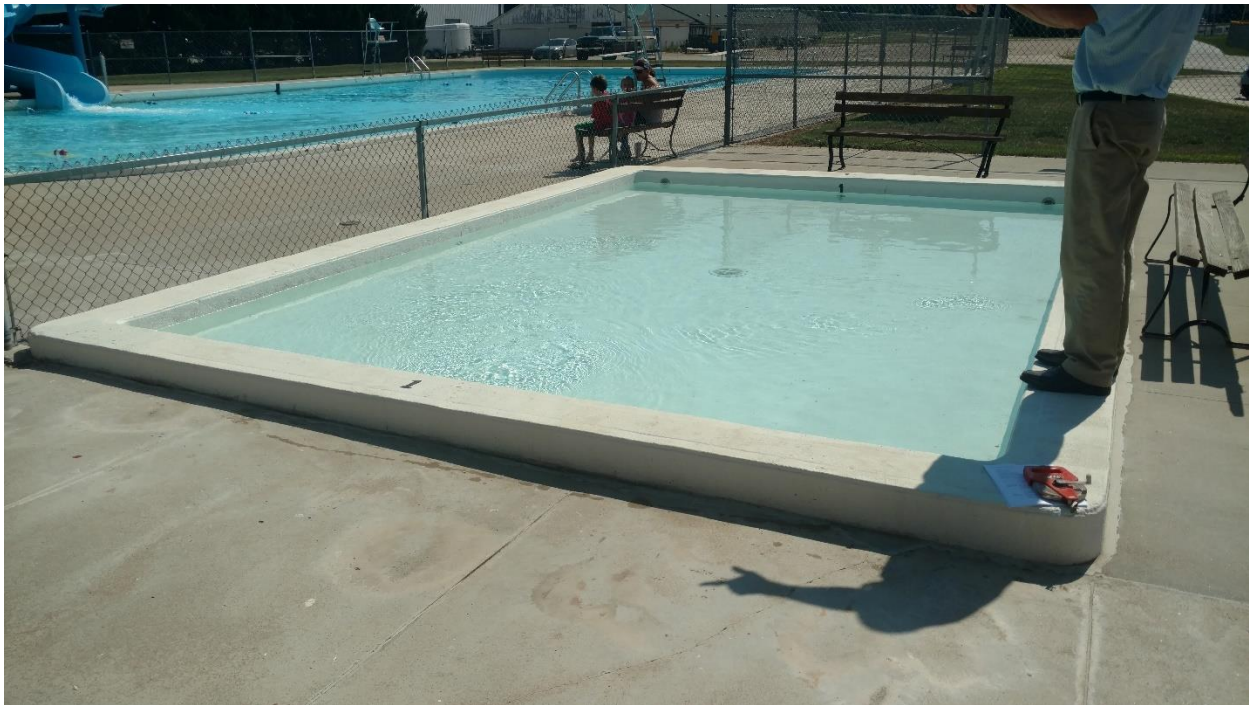
Figure 2-5: Wading Pool

The wading pool does not appear to have any major structural issues; however, it is not ADA compliant since there are no accessible entrances into the wading pool with a railing. The Virginia Graham Baker Act (VGBA) requires that all public pools and spas that have a single drain other than an unblockable drain must employ one or more additional options. In other words, there must be more than one drain in all pools to prevent entrapment underwater. The wading pool only has one drain.

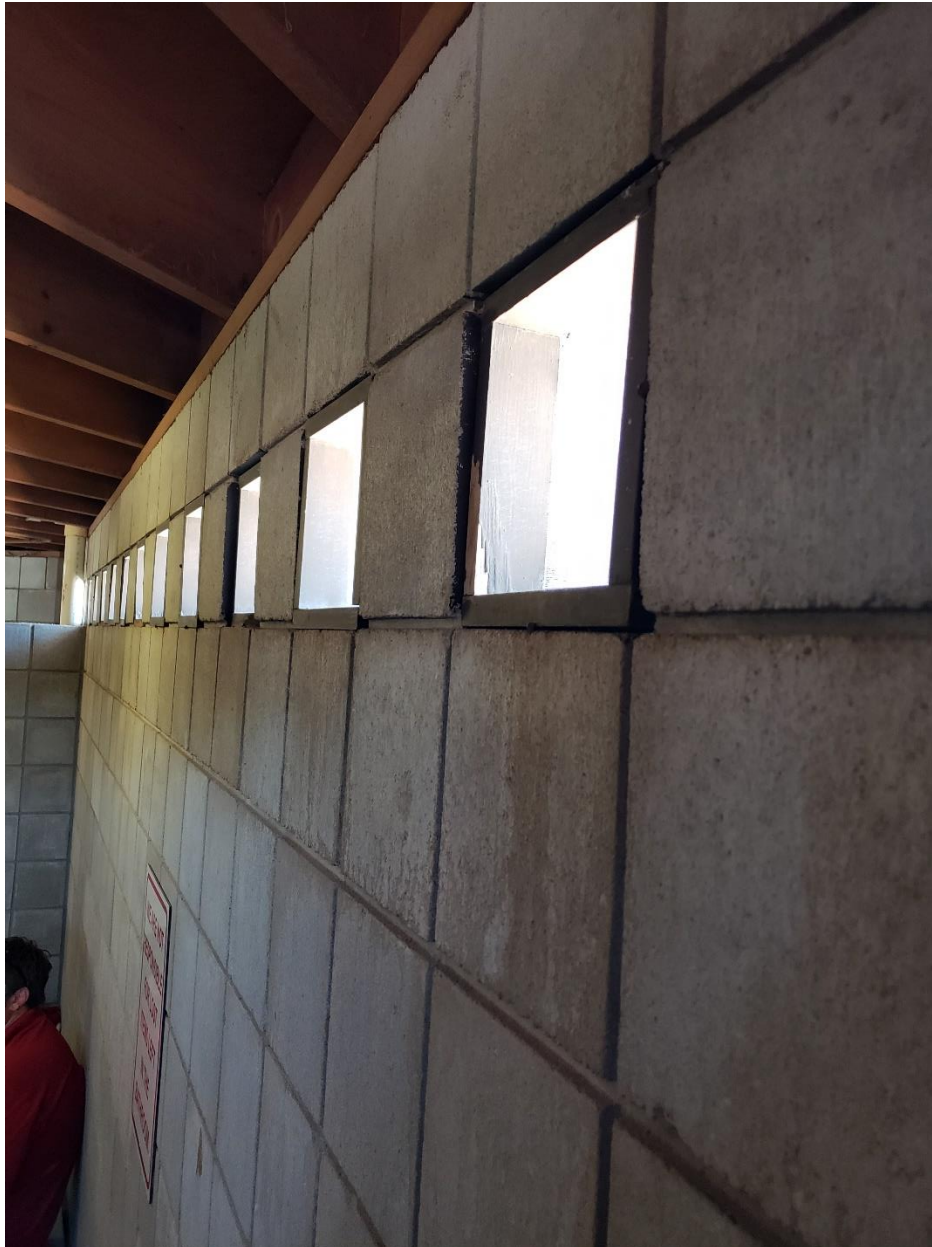
Figure 2-6: Locker Room Ventilation

The pool's bathhouse is a concrete block building with a wood rafter ceiling, and a typical shingle roof. see **Figure 2-8: Bathhouse**. It is made up of a men's and women's locker room and an administration area with an electrical closet. Each locker room is accessible with a door on each side of the administrative area. There is open air ventilation in both locker rooms, see **Figure 2-6: Locker Room Ventilation**. The locker room doors each have an electronic keypad lock system. Inside the electrical closet is an electrical breaker box, a water heater, and some miscellaneous cleaning supplies. There is some minor cracking in the lower parts of some walls seen in **Figure 2-9: Cracking in The Bathhouse Wall**. There is no adequate turn around space to meet ADA requirements in the bathhouse locker rooms.

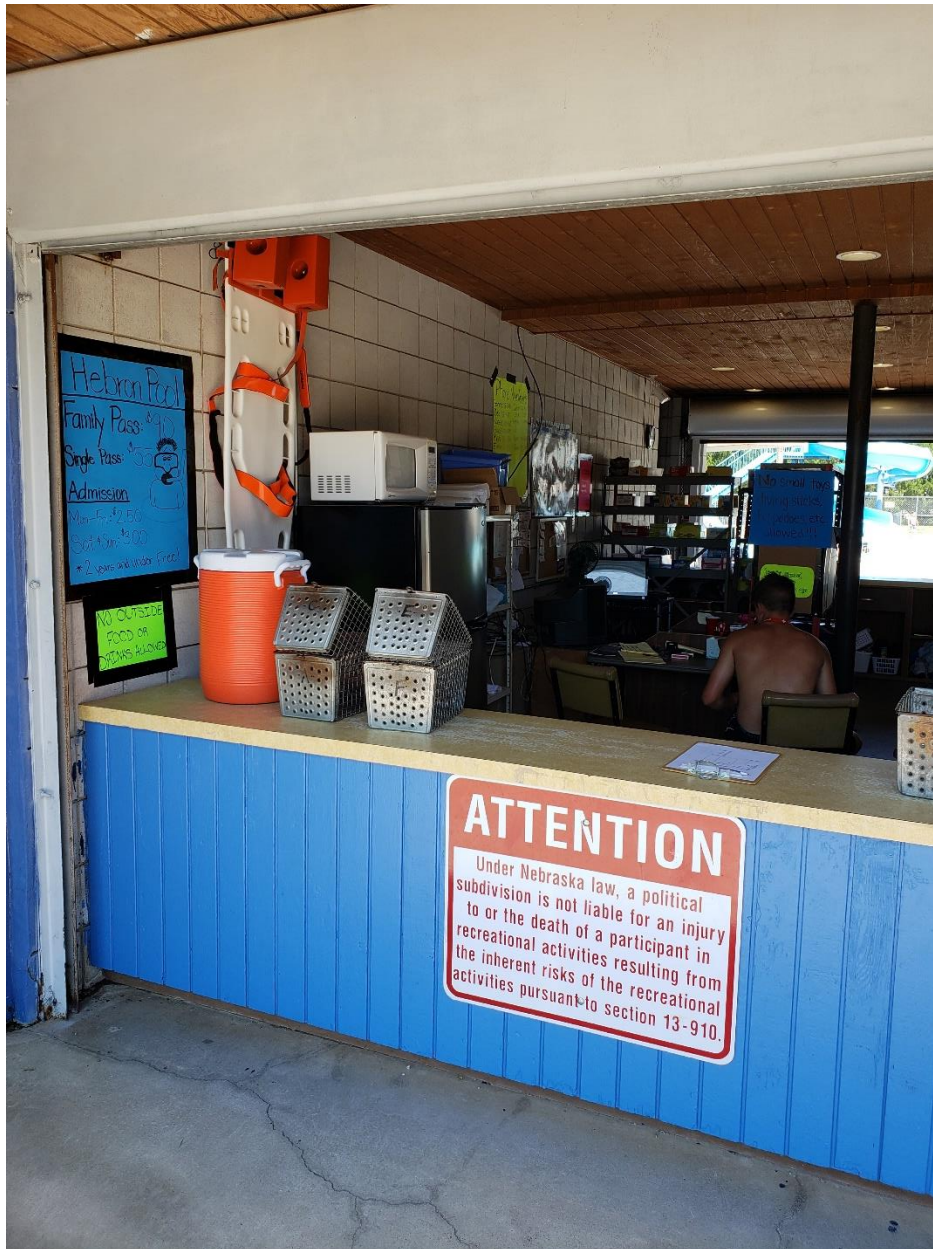
Figure 2-7: Bathhouse Administrative Area

The entrance into the building and the entrance from the building into the pool are both metal roll up doors, walking through either of these doors from the outside will bring you to the administration area of the bathhouse. Customers pay at the front, then go into the locker room and come out on the other side to the pool. On that side is a small concession stand. The administrative area is also a breakroom/office for the pool staff to sit in, see **Figure 2-7: Bathhouse Administrative Area**

The Bathhouse has been broken into before and because of this, a video camera linked directly to the police station was installed to watch over the administration area. The building also has a phone line and internet access.

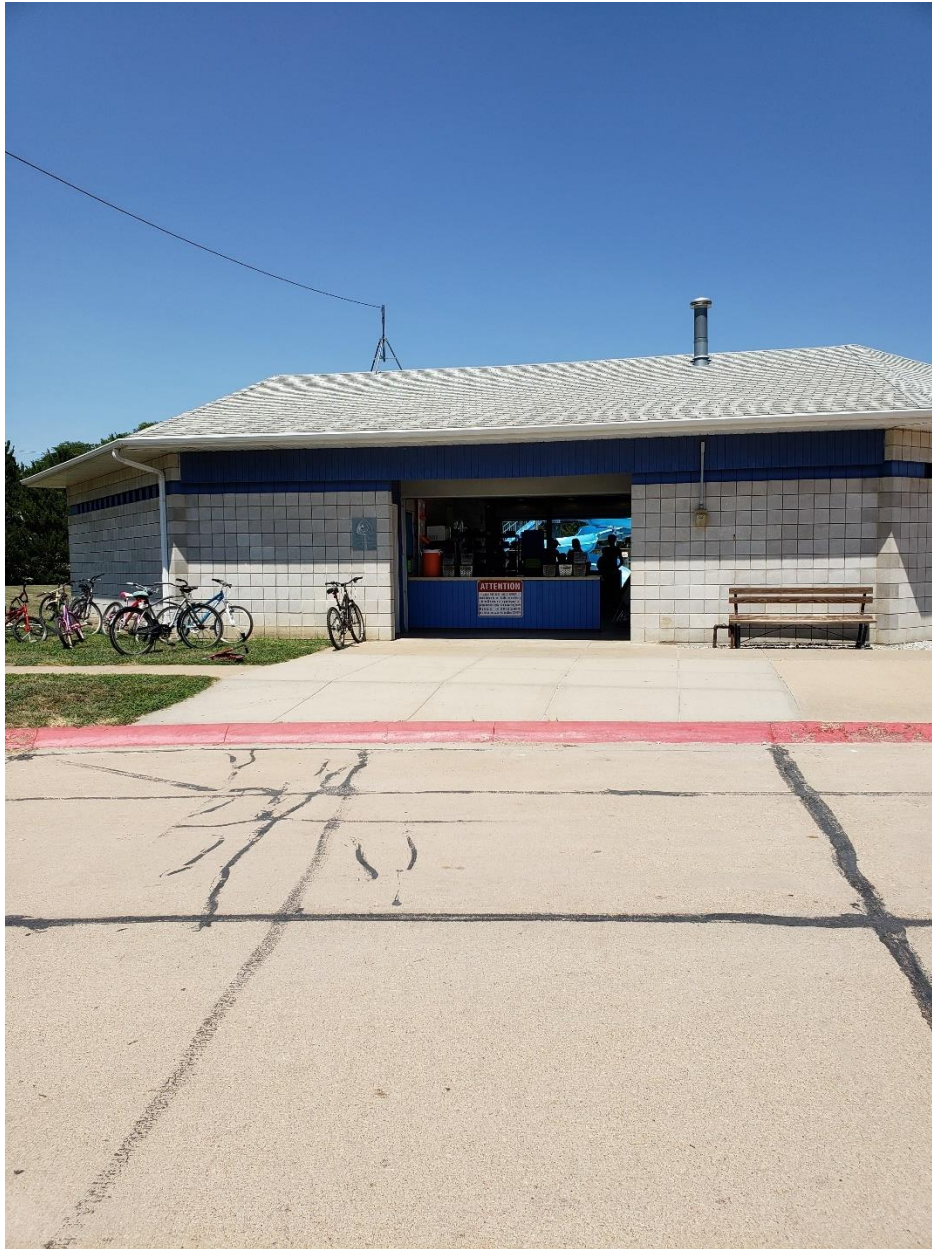
Figure 2-8: Bathhouse

City staff indicated the plumbing and toilets need to be redone. The bathhouse does not drain properly and there have been several times over the years when after start-up a new leak has appeared and needed fixed.

4. Replace plumbing and toilets in existing bathhouse.
5. The capacity of the pool is currently listed as 290 patrons. Current design standards indicate the max patron Load should be 200 based on bathroom fixtures in the bathhouse. The limiting factor is the toilets in the women's restroom.

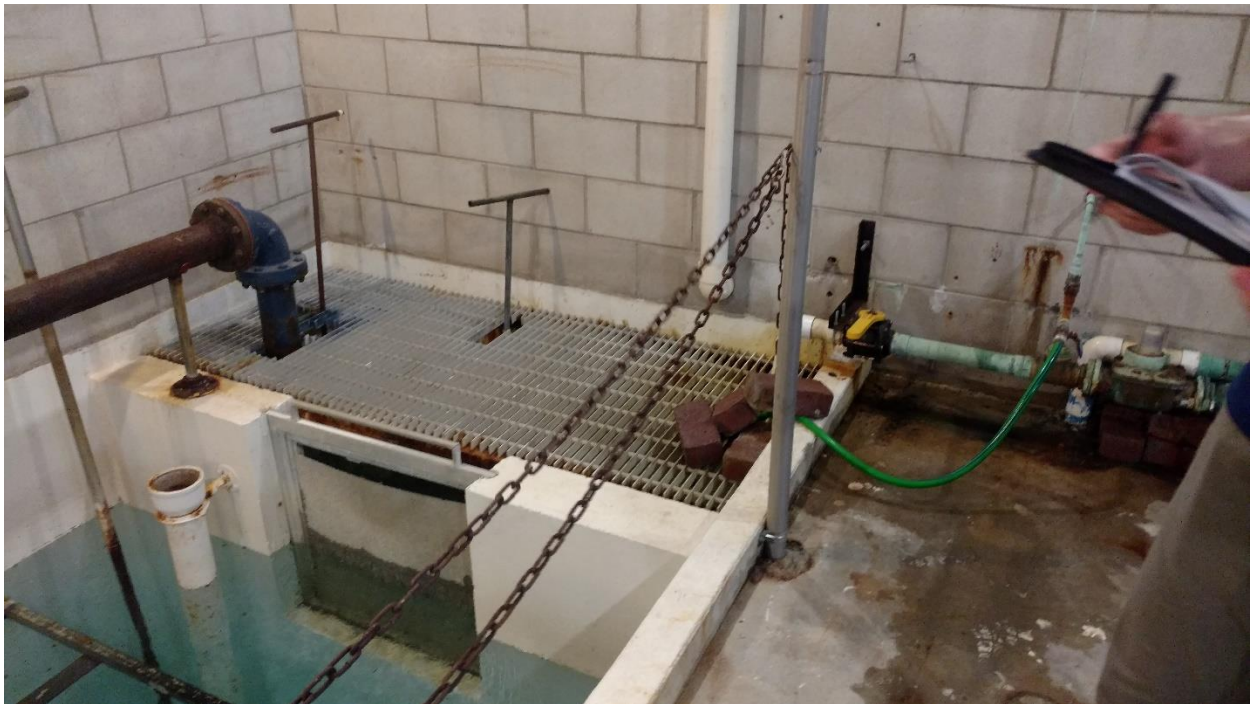
Figure 2-10: Surge Pit

At the start of the season, the surge tank is filled from a nearby water tap. This water is sent through multiple gravity diatomaceous earth filters where it is then pumped back into the pool through

multiple inlets. During everyday use, water is recycled from the pool to the surge tank from the gutters on the north and south walls of the pool, and a garden hose is running continuously to maintain the pool water level which drops due to leaks. This garden hose and the valve for the gutter drain and main drain to can be seen in **Figure 2-10: Surge Pit**.

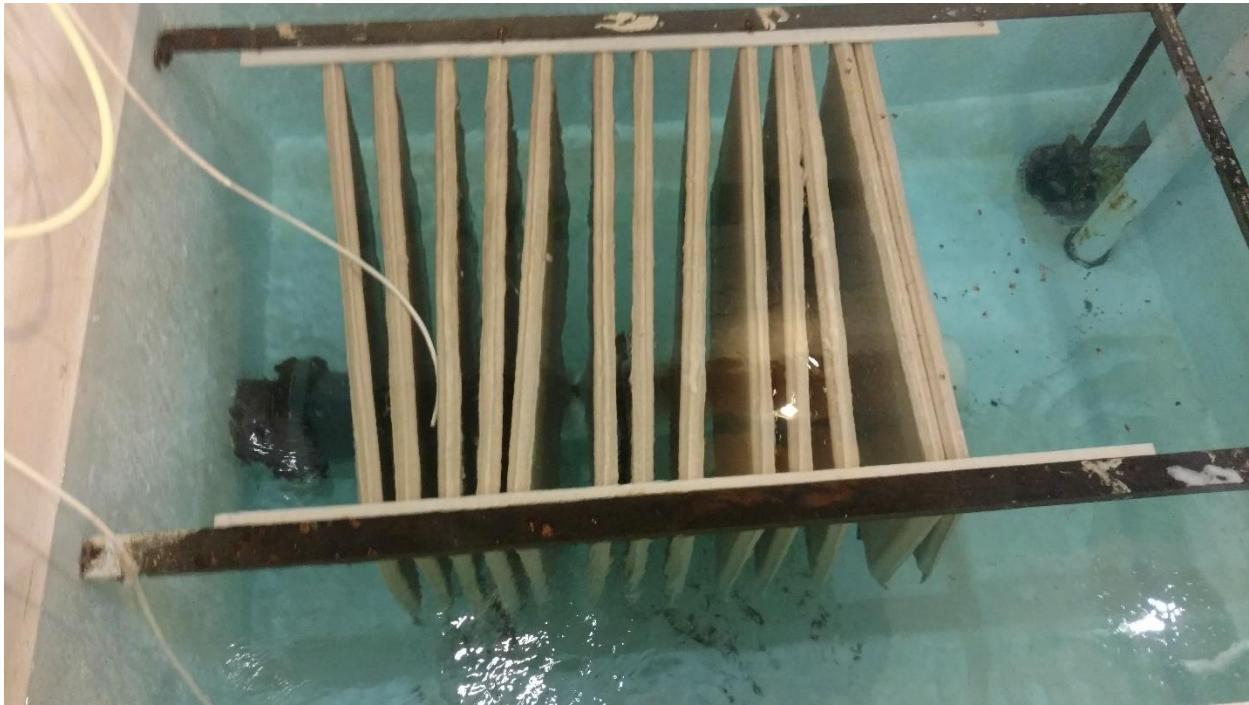
Figure 2-11: Filter System

The filters are hollow rectangular plastic boards with a cover full of diatomaceous earth material over them. Water is pulled through the diatomaceous earth material and into the boards. There are multiple small holes at the bottom and the water is sent through to a large collection pipe attached to the recirculation pump. The layout of the filter system can be seen in **Figure 2-11: Filter System**. When it comes time to clean the filters the City has to drain the tank, take the filters out, and hoses them down the drain. The filters are replaced every 2 years.

19. Replace existing filter system with new Pressure Sand Filter system. City staff indicated it takes about 1-1/2 hours approximately every 3rd day to backwash the existing filter system. A pressure sand filter takes about 15 minutes to backwash.

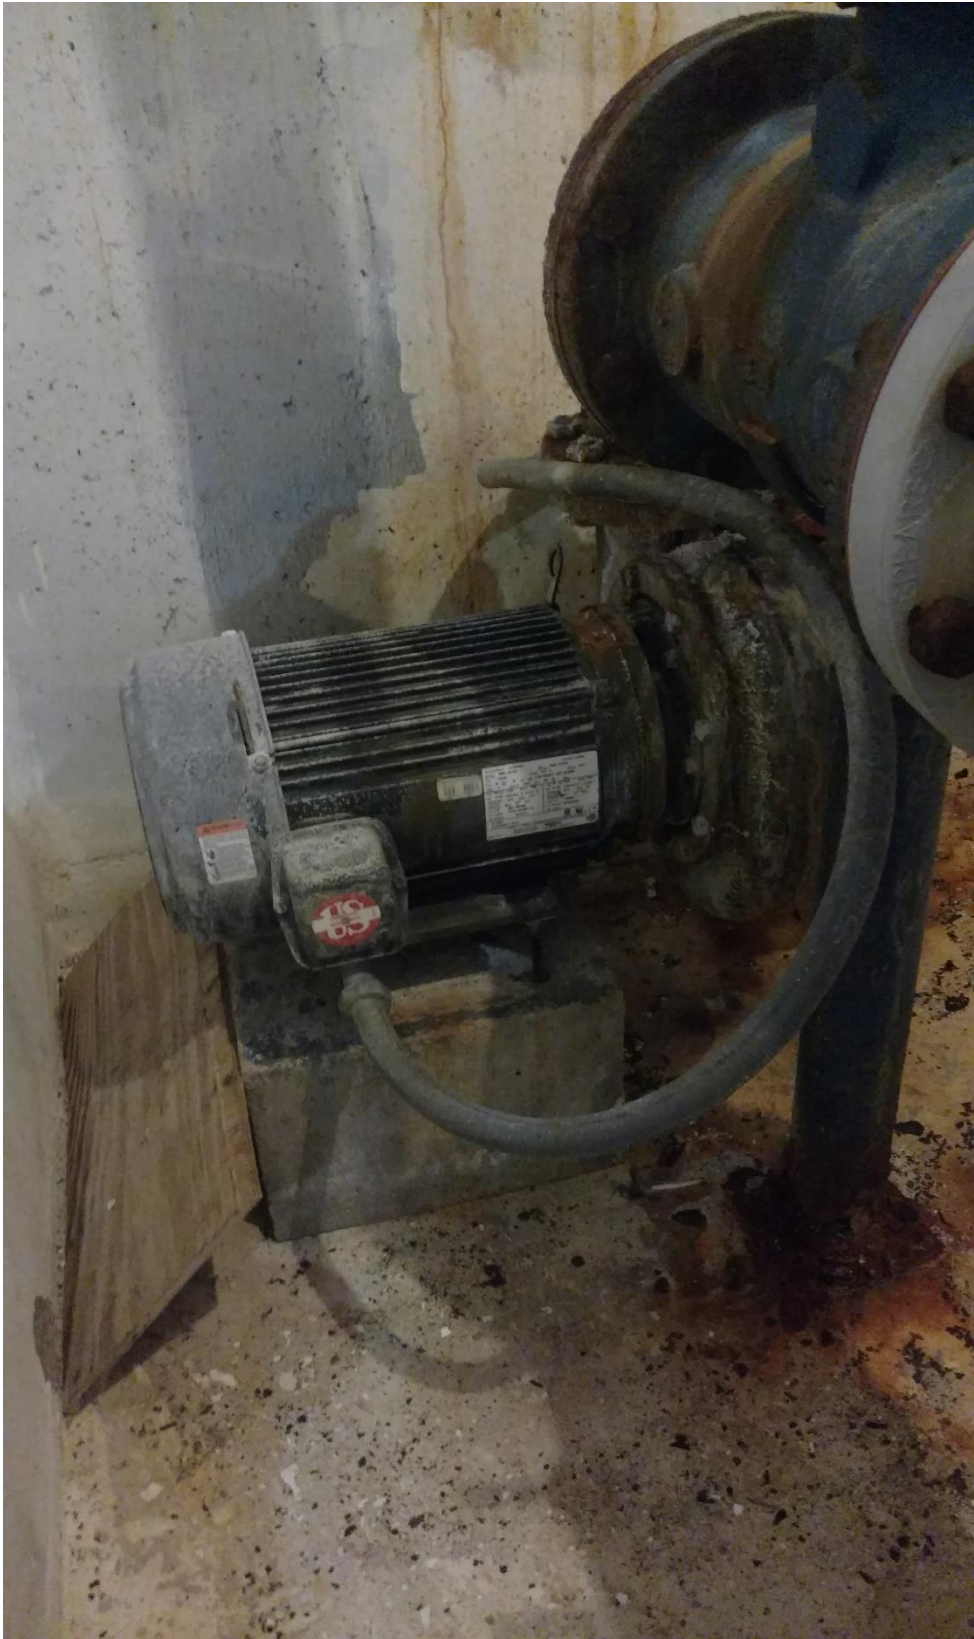
Figure 2-12: Pump

The pump is in the bottom of the dry half of the surge pit. It is run on a 10 hp motor. At the time of the site visit the flow meter was not functioning and the flow rate could not be verified. See **Figure 2-12: Pump**.

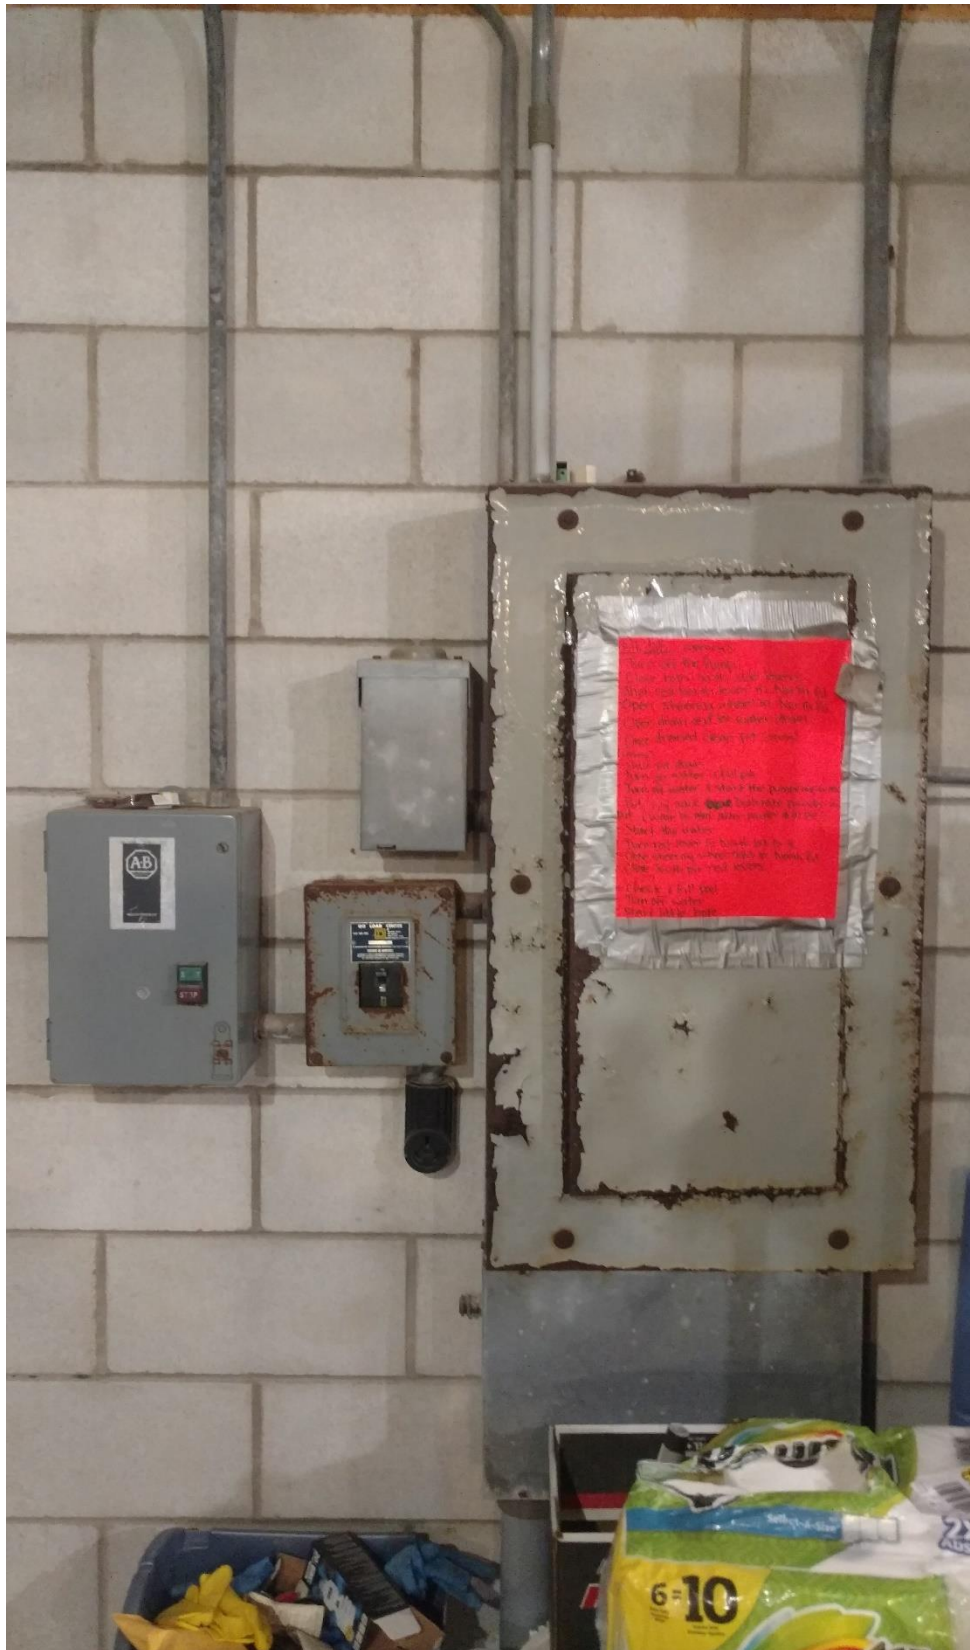
Figure 2-13: Electrical System Condition

The mechanical building houses the surge pit, filters, pump, chemical feed system, and electrical. The building is in decent shape but did not have ventilation until 2018. As a result, everything that's made of metal including all of the electrical system is heavily corroded from the chemical system.

The electrical service to the facility is 240-volt 3 phase. The electrical control system for the pool and mechanical building is located in the main room of the mechanical building. It is heavily corroded due to the building also housing the chemical feed system and not having ventilation until 2018. It is the opinion of this report that none of the electrical system is salvageable. **Figure 2-13: Electrical System Condition** shows the condition of the fuse box in the mechanical building.

7. The electrical system is original to the facility and in need of replacement. It has been severely corroded by the exposure to the chlorine over the years. The priority would be to separate the electrical from the chemical feed and/or move one of them outside.

The electrical equipment in the existing mechanical room is original to the facility and in poor condition due to its continued exposure to chlorine. The electrical in the mechanical bulding is proposed to be replaced with new electrical equipment designed for the new mechanical improvements. The nighttime lighting system will be replaced to meet current standards and to provide a viable option to the community if they want to use the pool after hours.

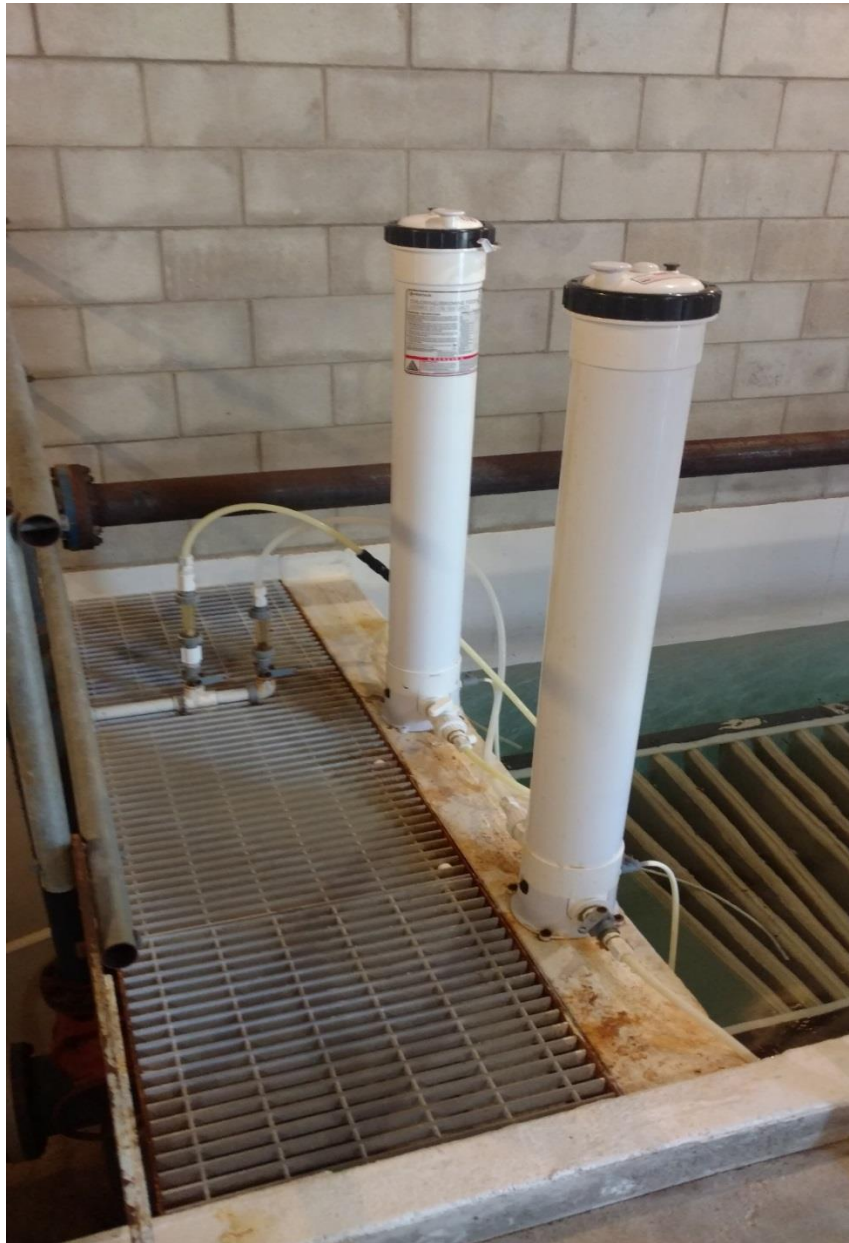
Figure 2-14: Chemical System

The chemicals are added to the pool through the two chemical pumps seen in **Figure 2-14: Chemical System**. Essentially, they work by putting multiple chemical tablets in the top of the pump. The pump then pumps a little water out from the surge pit and runs it over the tablets. This water flow erodes the tablets and creates chlorinated water that is then put back into the surge pit to go through the filters and into the pool. The tablets have stabilizer in them so there is no need for acid to be added to the pool to maintain pH balance. Up until 2018 there was no ventilation in the mechanical building and the chemical feed system was causing a lot of other equipment in the mechanical building to rust and corrode.

6. It is good practice to have chemicals separated from equipment such as pumps, filters, and electrical. The City of Hebron does not have a separate chemical room or provide proper ventilation. This has caused the equipment to rust and strong chlorine fumes to be present in the Mechanical Building. Part of this priority would also be to upgrade to liquid chlorine which can be better contained.

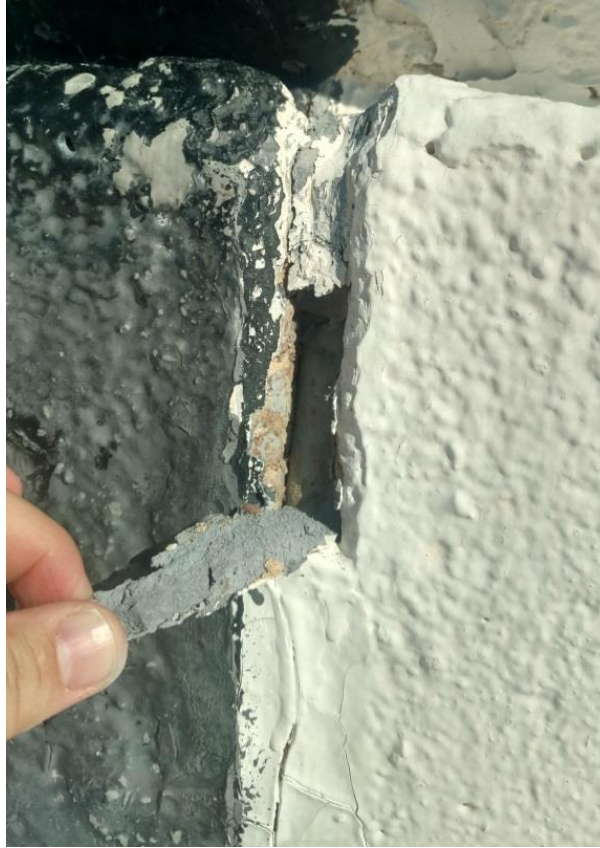
Figure 2-15: Pool Joint Failure

Leak Investigators performed an onsite inspection on August 15, 2018 with the pool full of water. They performed a Mic and Dye test on the main pool, baby pool, and surge tank. The investigators said the Mic test in the main pool was 'loud'. Although the main pool was leaking, the leak could not be pinpointed to a single location. The investigation noted that expansion joints have failed in the walls and floor in multiple places.

Leak Investigators performed a second onsite inspection on September 18, 2018 with the pool empty. The pool piping was pressure tested and was found to hold pressure. A visual inspection of the joints confirmed the expansion joint have failed and were likely leaking. The main drain grates were removed and it was found that all four sumps were cracked or failed, and the hydrostatic relief valves were all bad.

The leak investigation recommended removing the existing expansion joint material and re-sealing the construction joints. It also recommended new main drain sumps, hydrostatic relief valves, and VGB compliant covers.

The leak investigation found the construction joints were leaking and need repaired. The existing expansion joints will be clean out, primed, and sealed with caulk. This includes the horizontal

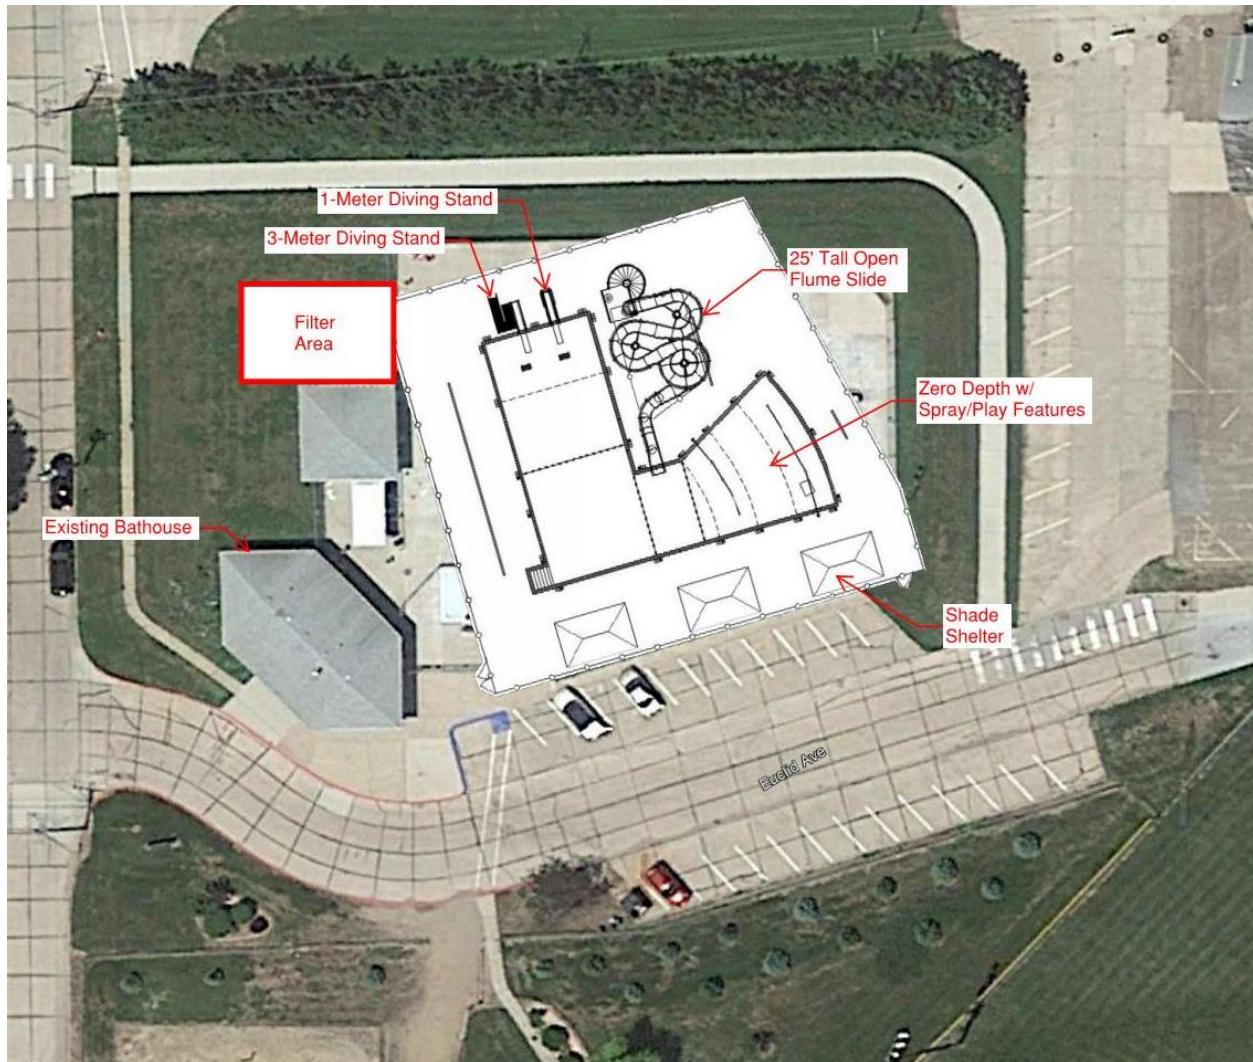
Figure 5-1 – Alt No. 2 Schematic

The new outdoor pool for Option No. 2 includes a zero-depth entry, four (4) 25-Yard lap lanes, water spray/play features, 1 and 3-meter diving boards, and a large slide. The new recirculation equipment for the proposed pool is tentatively planned to be located adjacent to the existing mechanical building, below a shade shelter, and surrounded by a slatted fence. An example layout that contains these features is provided in the following figure.

For the previous layout, it is estimated that the new facility would have approximately 2,000 gpm of total pumping flowrate (950 gpm for recirculation, 800 gpm for the slide and 250 gpm for the zero depth play features), approximately 4,200 square feet of water surface, a total estimated volume of approximately 162,000 gallons. The estimated capital cost for this option is following:

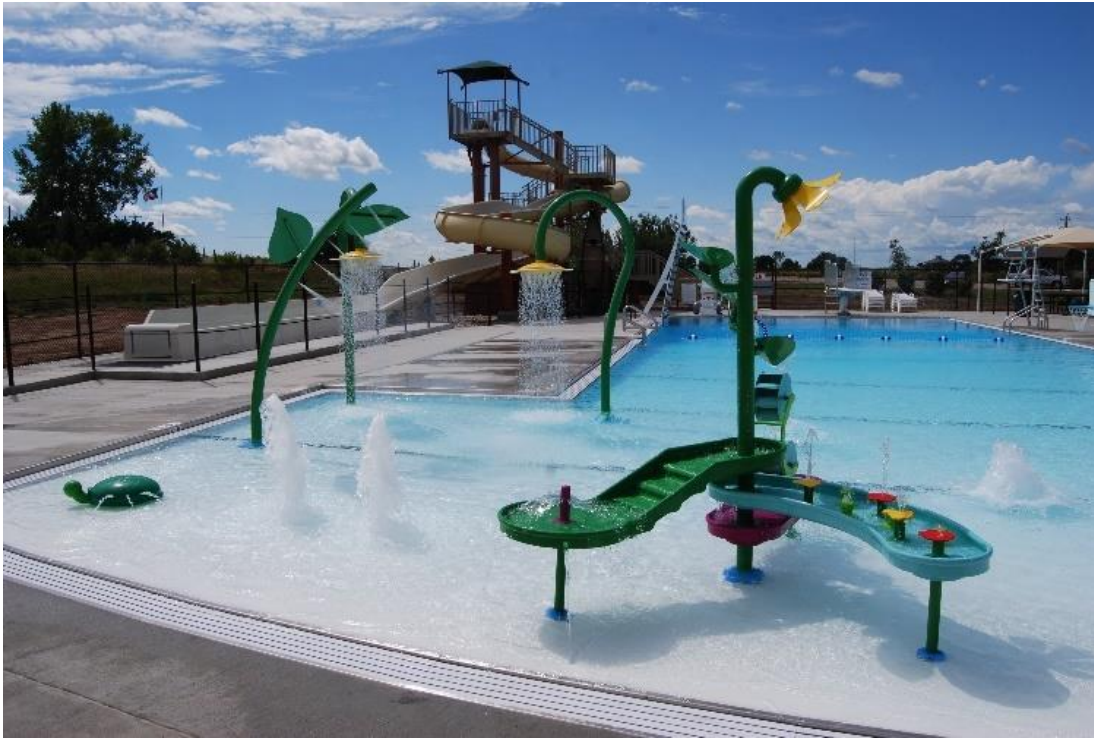
Figure 5-2: Water Spray Features in Zero Depth

Water Spray Features in Zero Depth: The zero depth allow patrons to enter a pool without the use of ladders, as if it were a beach that gradually slopes down, increasing in water depth. This area of the aquatic facility is extremely popular with the very young and elderly for a variety of reasons. For a facility of this size, adding water spray features in portions of the zero-depth area is a very popular trend and rates highly with patrons. Water spray features come in every imaginable shape and size, though generally speaking, the features are constructed of metal or plastic and are either flush with the floor (such as a ground spray) or extend up anywhere from 0'-6" to 24'-0". The features have varying flow rates and pressures to accommodate different user groups. For facilities of the similar size to this, it would be anticipated that several individual spray features be considered. These groups of features typically operate on between 100 and 250 gpm and require approximately 200 to 400 square feet of shallow zero depth area.

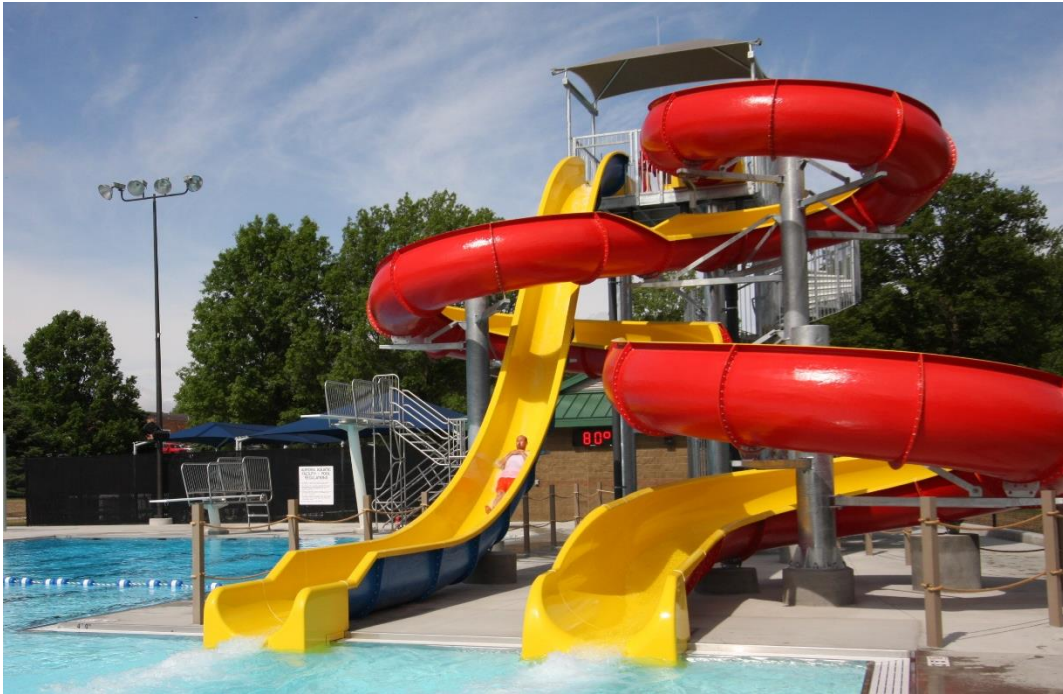
Figure 5-3: Waterslide

Waterslide: A large waterslide is recommended for a facility of this size. The slide should be incorporated into the original design, but the actual implementation of the slide could be accomplished in the future or as an alternate bid item. The main reason to provision for the slide at the beginning is to ensure adequate recirculation for the slide plunge location as well as for providing means of egress, adequate space for pumping equipment, and space for the slide itself. For a project of this scope, it would be recommended to design around a tower structure that would be approximately 25 feet tall, providing for a 150-linear foot ride. The slide tower would be designed to handle a single flume that would terminate into a designated plunge area of the pool.

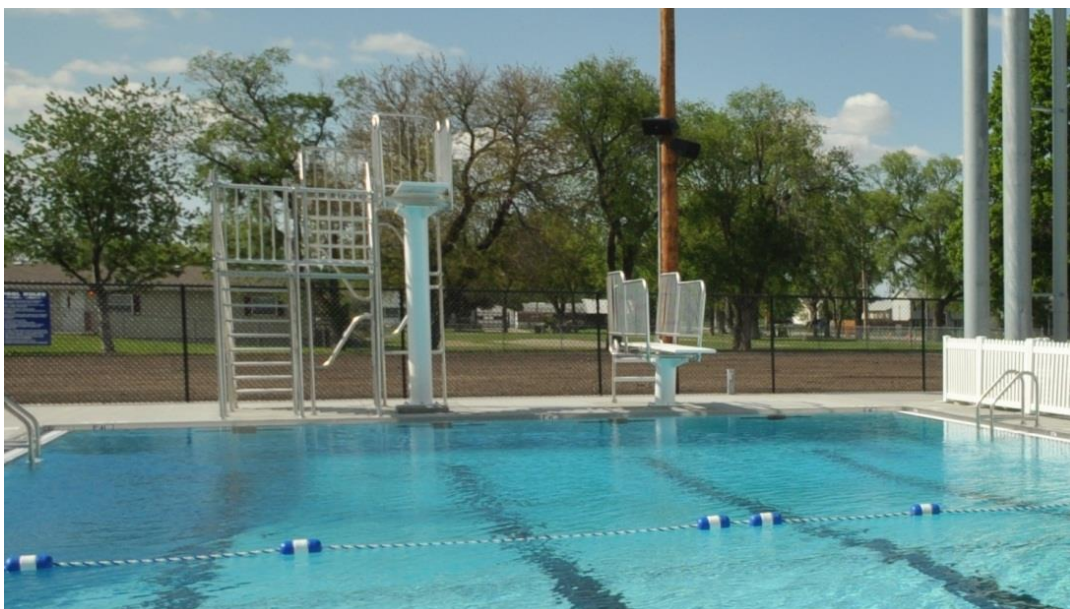
Figure 5-4: Diving Well with Diving Stands

Diving Well with 1-Meter & 3-Meter Diving Stands: A diving well is a term used to describe the area of a pool that has been designed and constructed for pool patrons to dive from a diving stand into the pool. The diving well is typically 10'-0" to 12'-6" deep. The current recommendation is to provide one (1) 3-meter diving stand and one (1) one-meter diving stand. Therefore, the deep end would be 12'-6" deep. After the diving well, the floor would rise at a 1 to 3 slope until reaching the 5'-0" depth.

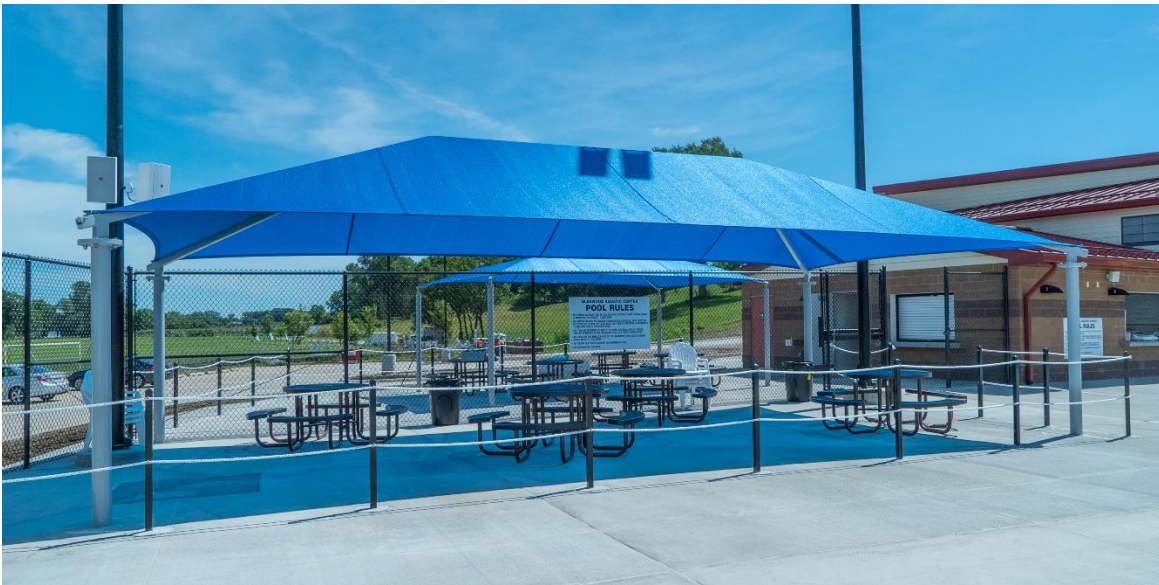
Figure 5-5: Shade Shelter

Concrete Deck and Shaded Deck Area(s): All new swimming pools should be provided with plenty of “deck” space around the swimming pool for both walking and lounging. Deck space should be of a solid surface that prevents tripping hazards and yet is slip resistant. For a facility such as the described, it would be recommended to provide approximately 15 feet of deck (minimum) around the entirety of the pool. This area is recommended to contain fabric style shade shelters for a good portion of the deck area. The fabric provides UV protection for patrons sitting below, but still allows for light to penetrate. When considering the quantity of deck space, it is important to consider the number of patrons whom enjoy the atmosphere of the aquatic center and not just the patrons entering the pool itself. Many parents and guardians prefer to lounge and read books, monitor children etc. from the sidelines.

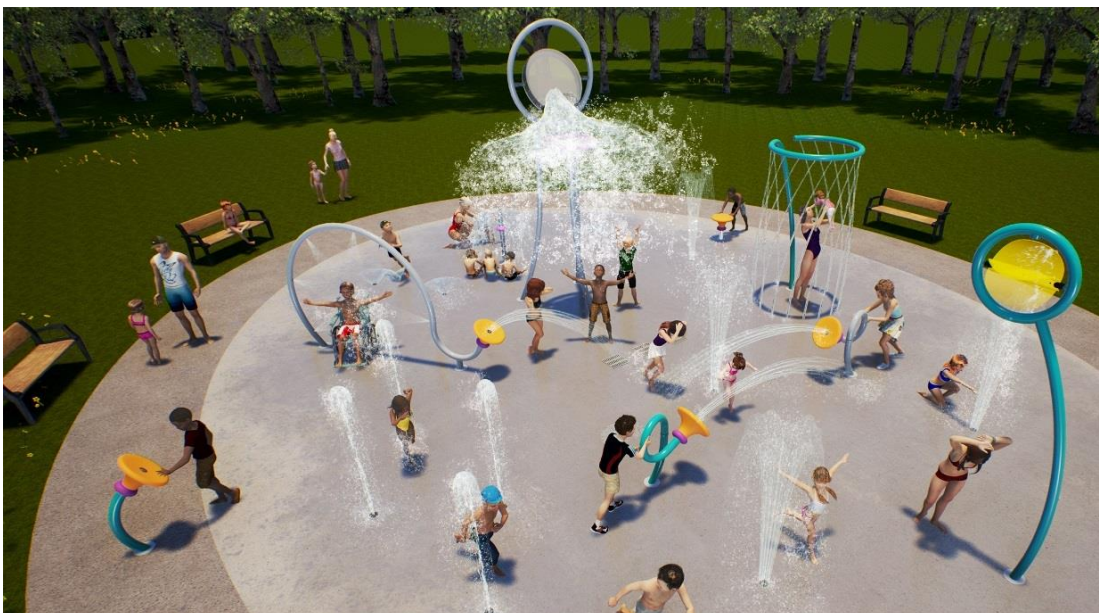
Figure 5-7: Alt No. 4 Schematic

The splash pad proposed for this option includes several different water spray/play features including, various ground geysers, above grade spray features, interactive spray features, and a large dumping bucket. An example layout that contains these features is provided in the following figure.

There are many options available for splashpads and/or splashpad themes. The City could further review and pick options during pre-design. Typically, splashpads are activated by a push button and set to run for a 6-12 minutes sequence. The proposed splashpad works off water system pressure and is a flow through system which does not require treatment. It is estimated that the proposed splashpad facility would use approximately 200 gpm when activated. The estimated capital cost for this option is following:
